Insight Earthworks Monitoring

The Challenge - Earthworks Monitoring

LB Foster Approach to - Earthworks Monitoring

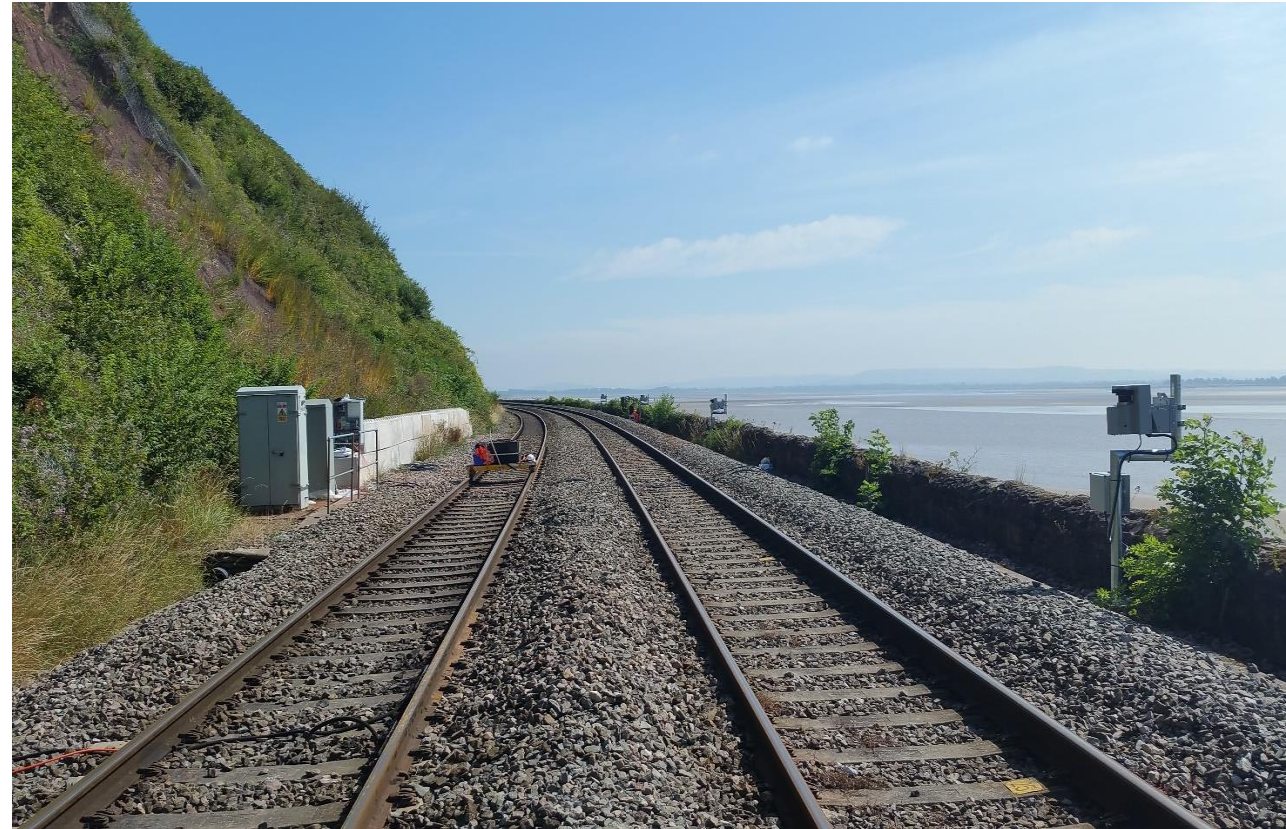
- Little Hagloe (Trial)
 - 15/12/2019
 - 16/02/2020
 - 28/08/2020 (Live)
Event 07:24
LiDAR 2 1.6m x 641mm
At 129m 460yd
Alert received 07:25
Trains stopped 07:28
 - 07/02/2021 (Live)
- GE 2021 Award – Equipment Innovation

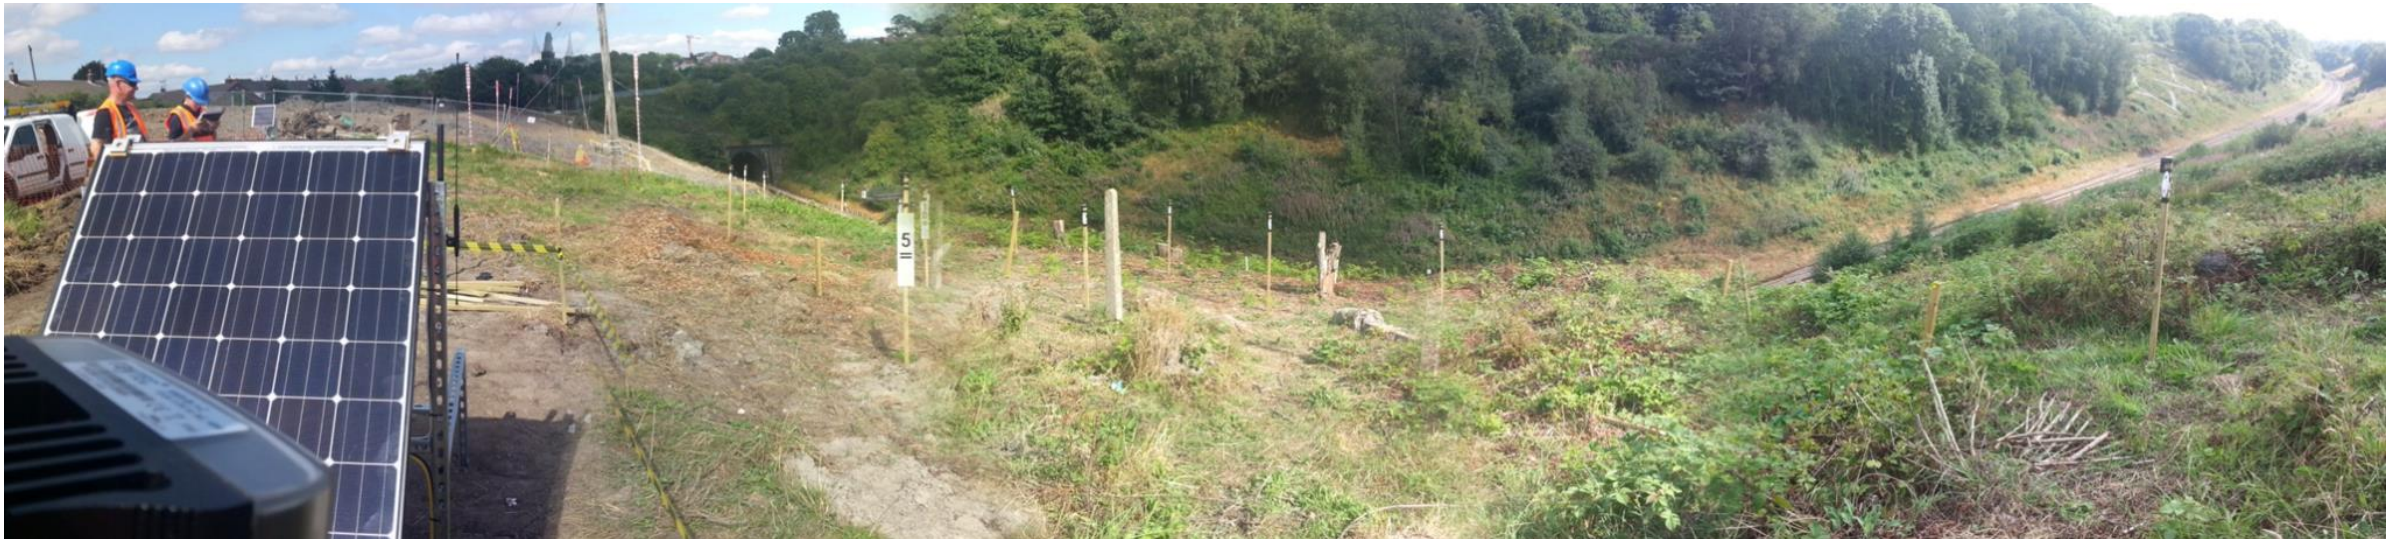
- Clay Cross – Known site, during remedial groundwork
- System deployed and operational in hours
- Movement posts with 3G accelerometers analysing multiple samples per minute transmitting hourly to web server
- Excessive movement detected triggers image updates and alarms
- HD photographs collected midday and midnight
- Custom 'Invisible' 980nm infra-red light developed

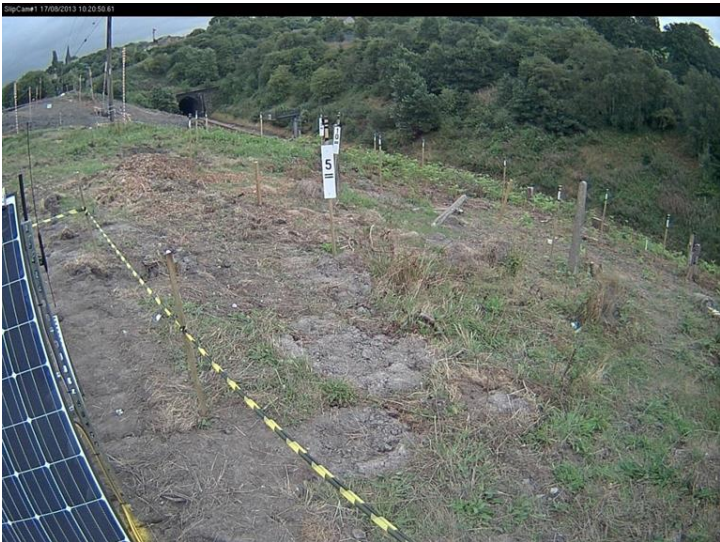
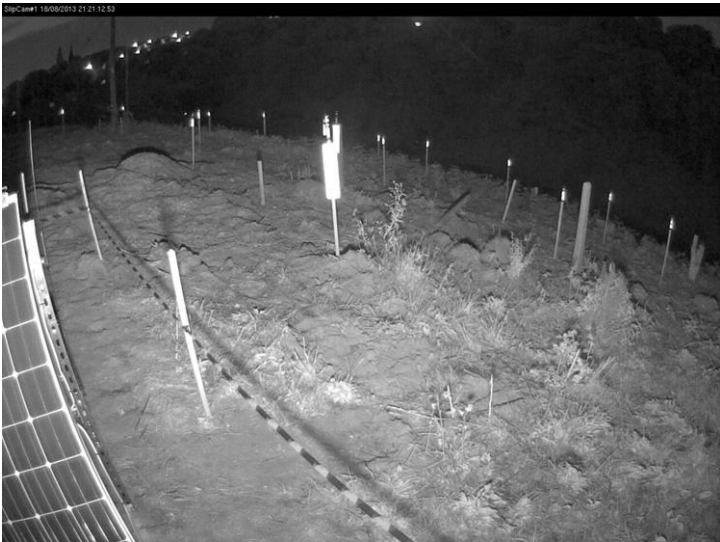
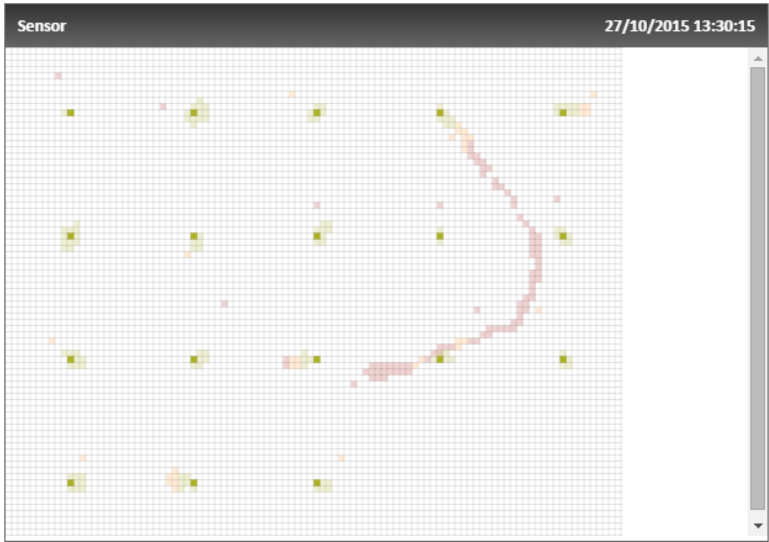
Tag: 00020081 Timestamp: 17/09/2013 13:00

X
Current X: -0.988g Original X: -0.988g Lower offset: 0 Upper offset: 0

Y
Current Y: -0.023g Original Y: -0.02g Lower offset: 1 Upper offset: 0

Z
Current Z: 0.008g Original Z: 0.012g Lower offset: 1 Upper offset: 0

Signal
-52dBm

Temperature
21°C

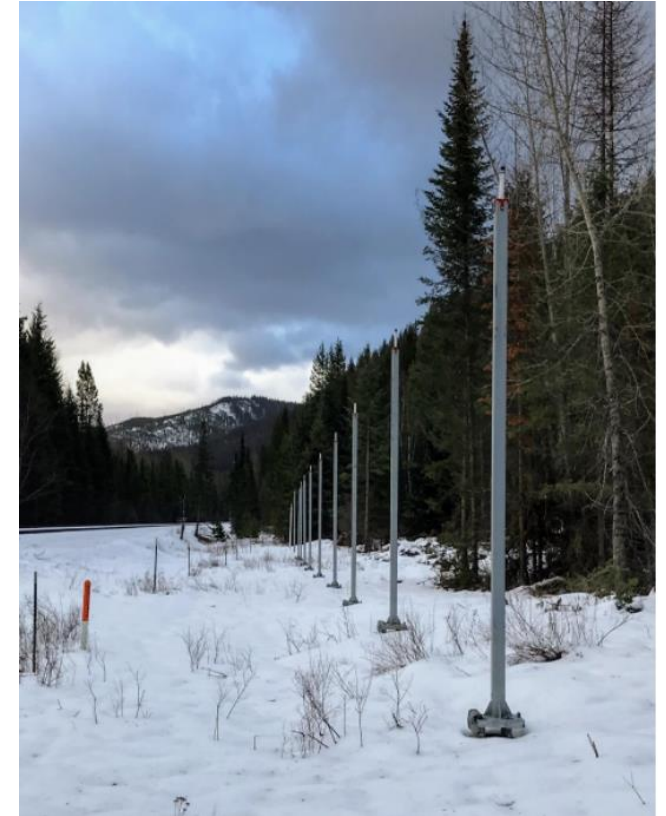
- North American (BNSF) installation
- Operational for over 4 years
- Comprises
 - Tilt Tag/Detectors, 4 minute heartbeat
 - Solar powered Gateway (3/4G)
 - Dedicated HMI, with onward alert messaging
 - Optional solar CCTV for remote verification of event

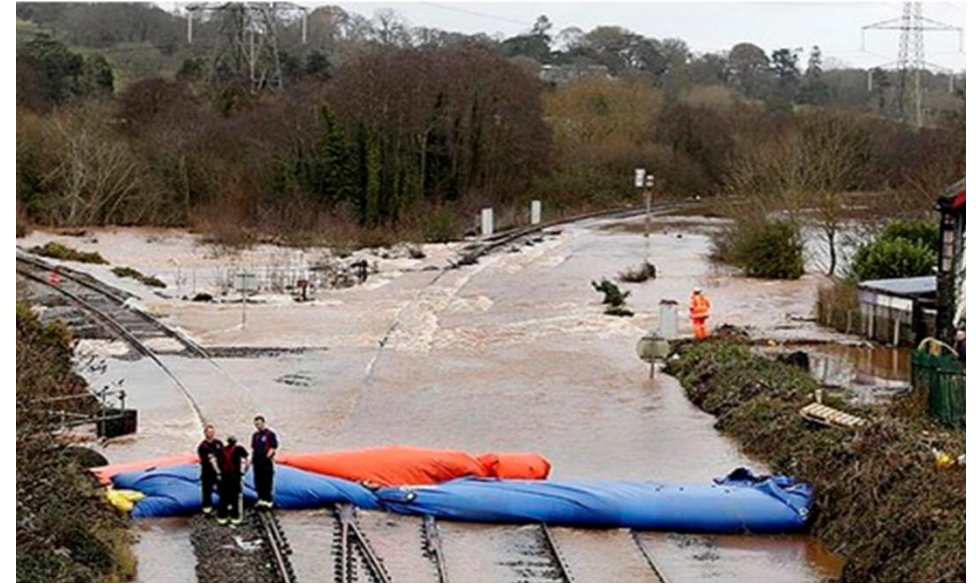
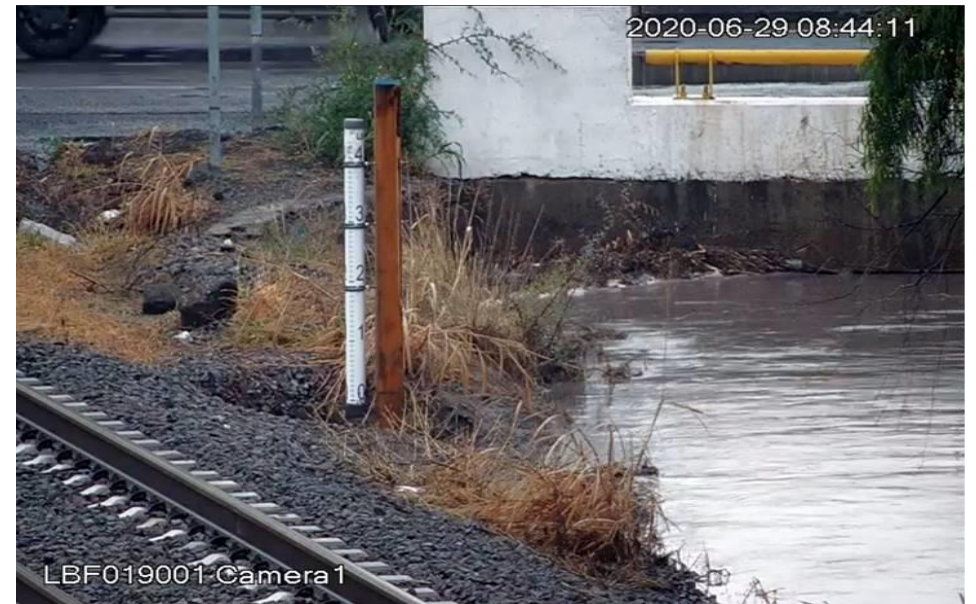
- > Nationwide flooding problems with over 200 known sites at risk
- > Often in remote locations with no available power or land based comms.
- > Wireless communication
- > Capacitive sensing technology
- > Maintenance and cleaning of units reduced significantly

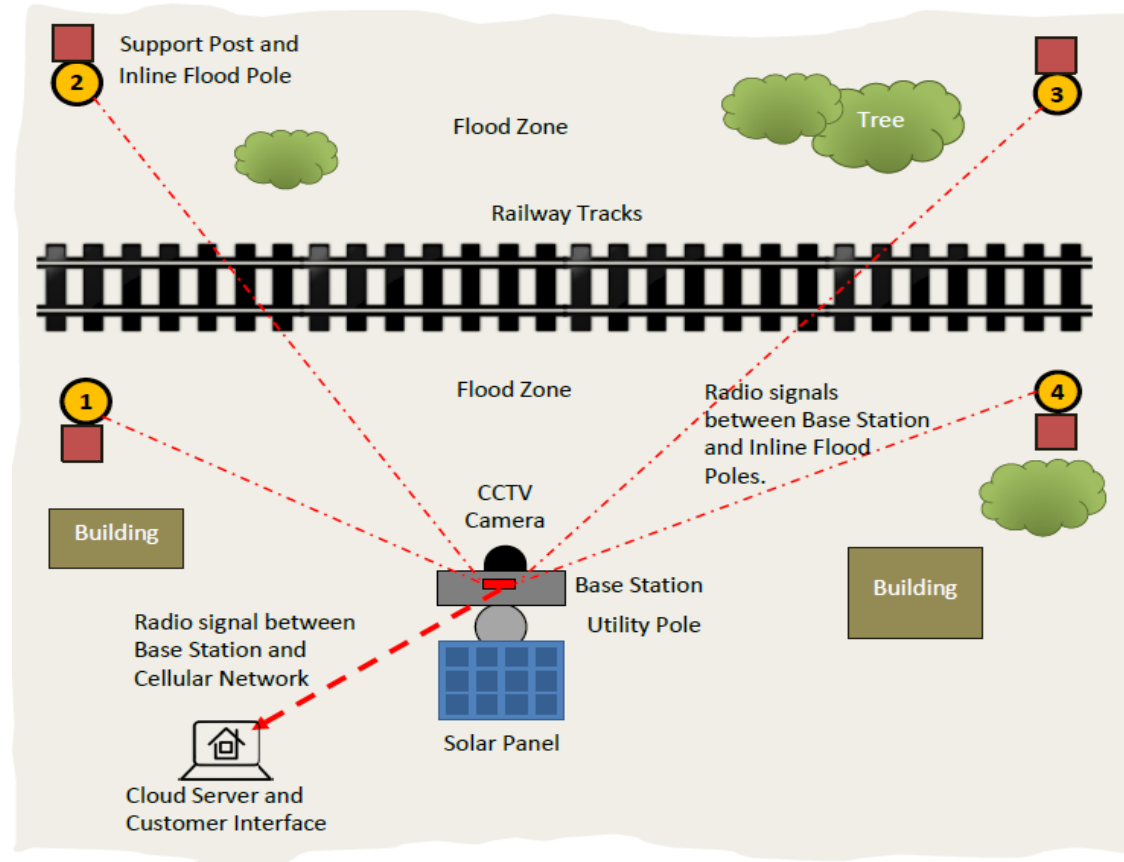
- > Communicates via intelligent gateway, triggers & alarms to secure server via 3/4G
- > Low powered CCTV for visual verification update, snapshots and live video
- > Automatically targeted CCTV for snapshots
- > Solar powered, battery backed
- > Web portal with user friendly software with RAG alarm status
- > Customised alarm levels for each location
